Cedar Area Fire & Rescue Station Evaluation

Completed By: Chief Doornbos

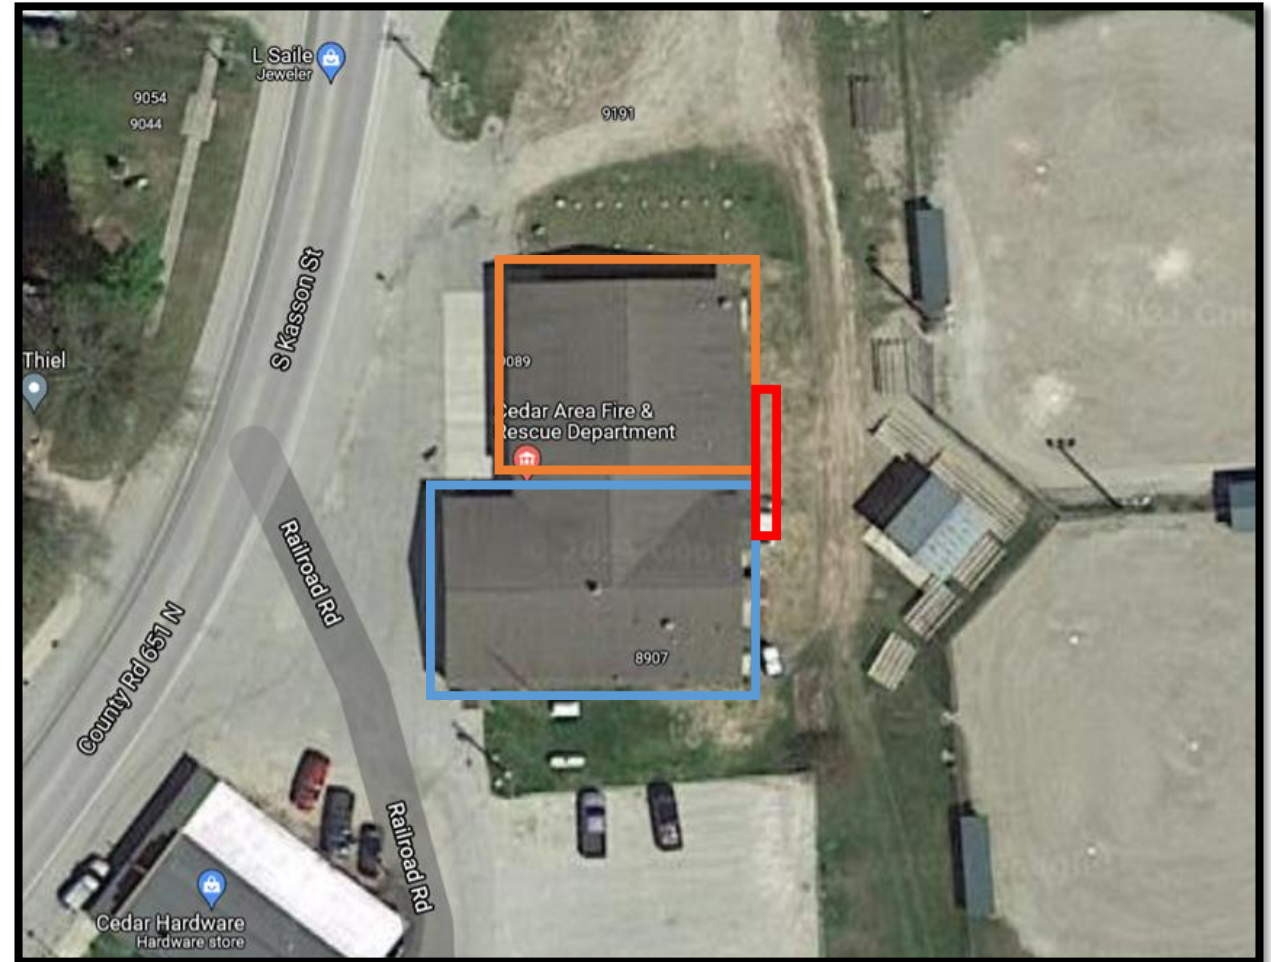
Current Conditions

-Exterior-

- A major hazard for our building is the roadway that runs between the hardware and the corner of our building. Numerous instances of close calls have resulted in the orange barrels that you may see at the corner of our building. As we pull out from the apparatus bay we cannot see vehicles coming down Railroad and they cannot see us. This is an issue that we are working on with the road commission.
